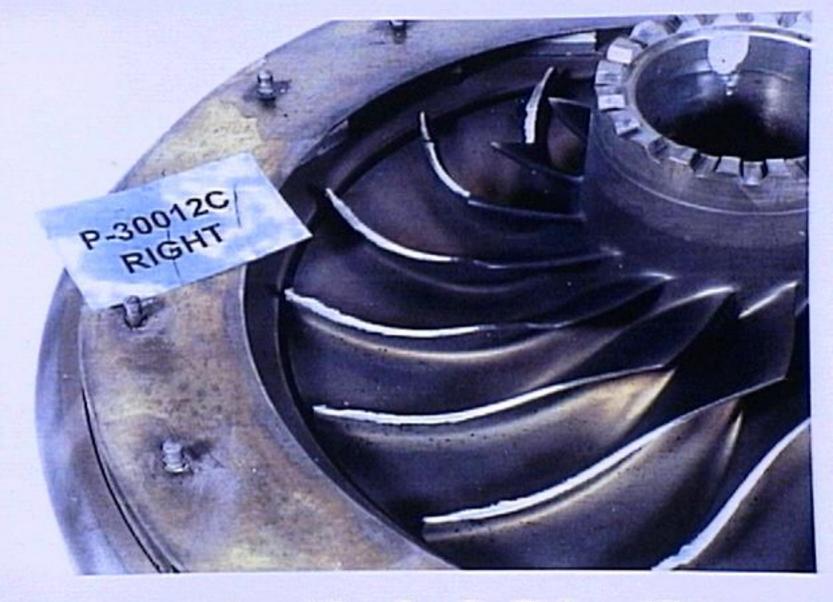
e 115. Soot on the Second-Stage Impeller Blades and Flowpath
